ANNUAL REPORT FOR 2007

Smith Creek Mitigation Site

TIP No. U-0092 A/B

Prepared By:
Natural Environment Unit & Roadside Environmental Unit
North Carolina Department of Transportation
October 2007

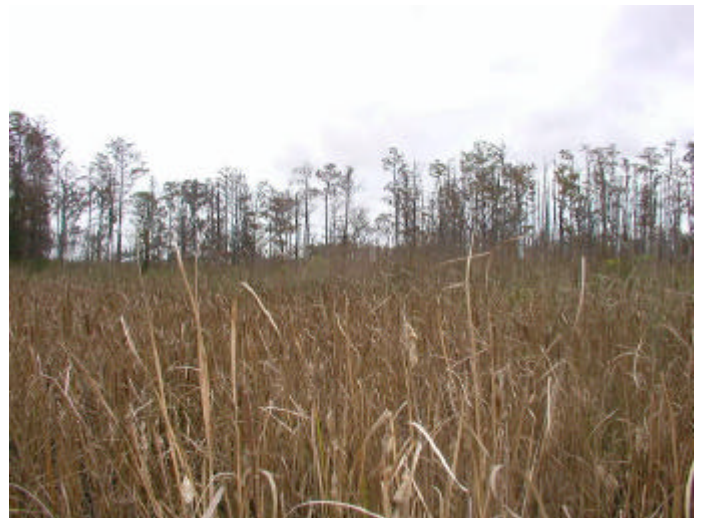
Photo 4

Since, the 2006 monitoring evaluation photos 4, 5, and 6 were taken within the site, instead of the bridge due to traffic being turned onto the Smith Creek Parkway.
